INSTRUMENTATION APPENDIX TO
PERIODIC INSPECTION REPORT NO. 5
UNION VILLAGE DAM, VERMONT

Haley & Aldrich, Inc.
Cambridge, Massachusetts

Department of the Army
New England Division

File No. 11163-006
July 1995

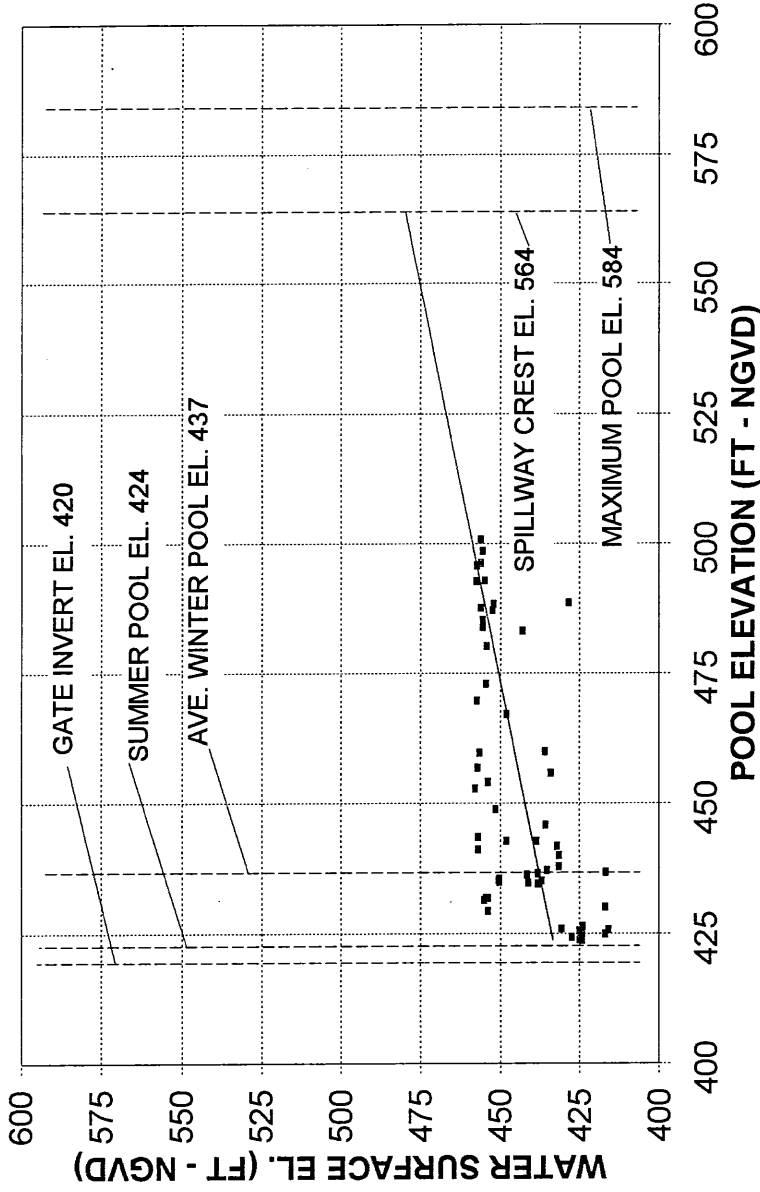
During the winter months, the average water level in PZ-B-3 is approximately El. 440, up to 5 ft higher than the normal pool level ranging from El. 435 to 438, as noted in Table II. In summer months the average water level is approximately El. 424 for pool levels ranging from El. 424 to 426. Based on the available data (October 1, 1992 through October 31, 1994), the piezometer responded to changes in pool elevation as shown in Figures 14. A noticeable response to the flood events of April 93 and April 94 can be seen in Figures 14 and 17. The water level in the standpipe rose 40 percent of the pool level increase in April 93. Consequently, PZ-B-3 may still be linked to the underlying bedrock, and/or bedrock

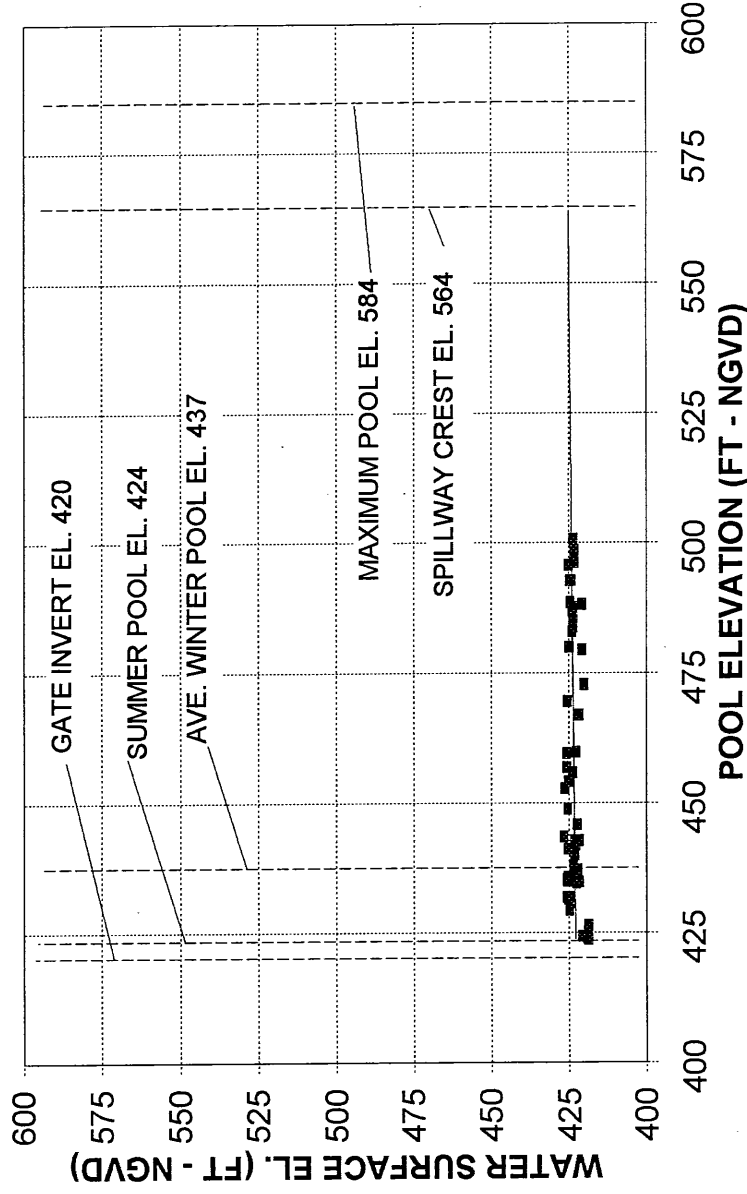
During the winter months, the average water level in PZ-A-3 is approximately El. 424 for pool levels ranging from El. 435 to 438, as noted in Table II. In summer months the average water level is approximately El. 420 for pool levels ranging from El. 424 to 426. Based on the available data (October 1, 1992 through October 31, 1994), the piezometer responded to changes in pool elevation as shown in Figures 14. The measured water levels in PZ-A-3 appear to respond linearly but in small proportion to changes in pool elevation as shown in Figure 19. The smaller range of piezometric levels for PZ-A-3 is to be expected due to its location beneath the downstream slope at the toe drain-foundation soil interface; the drain outlets to tailwater which varies from about El. 419 to 421. Based on a linear projection, the water level in the piezometer should rise to only El. 425 when the pool reaches the spillway crest, El. 564.

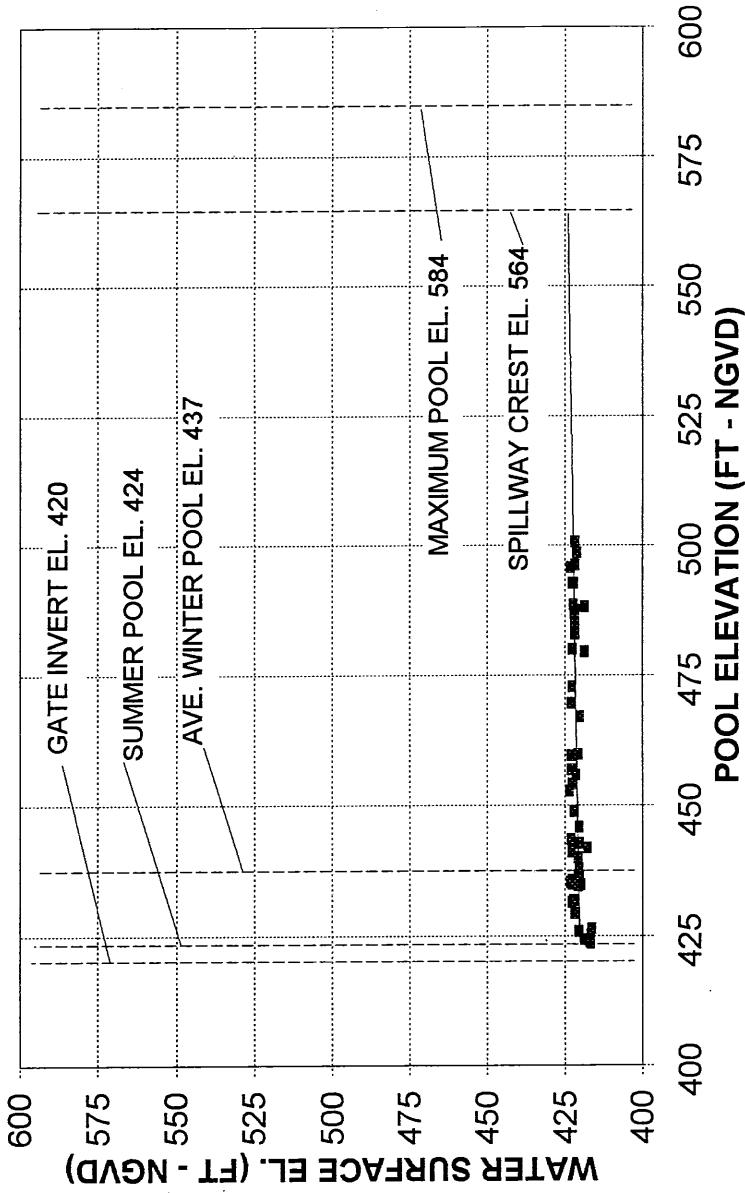
During the winter months, the average water level in PZ-A-4 is approximately El. 421 for pool levels ranging from El. 435 to 438, as noted in Table II. In summer months the average water level is approximately El. 418 for pool levels ranging from El. 424 to 426. Based on the available data (October 1, 1992 through October 31, 1994), the piezometer responded to changes in pool elevation as shown in Figures 14. The measured water levels in PZ-A-4 appear to respond in a linearly but in small proportion to changes in pool elevation as shown in Figure 20. The smaller range of piezometric levels for PZ-A-4 is to be expected due to its location beneath the downstream slope at the toe drain-foundation soil interface; the drain outlets to tailwater which varies from El. 419 to 421. Based on a linear projection, the water level in the piezometer should rise to El. 424 when the pool reaches the spillway crest, El. 564.

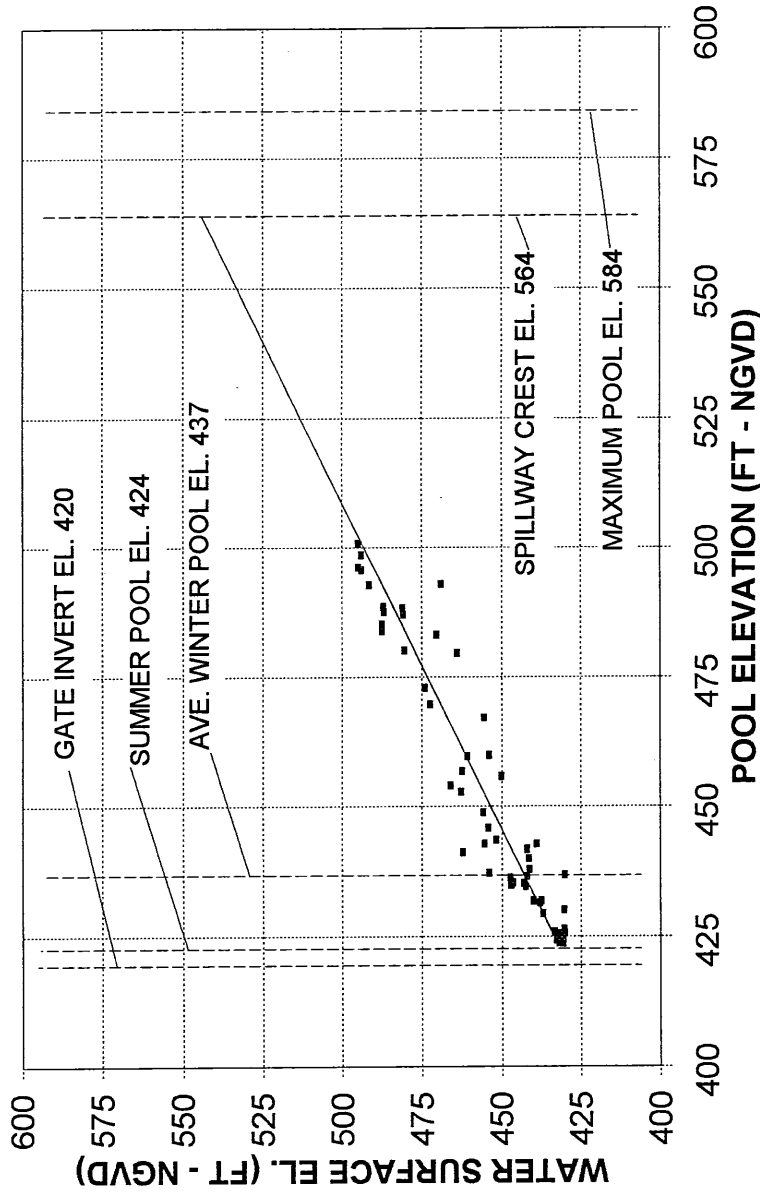
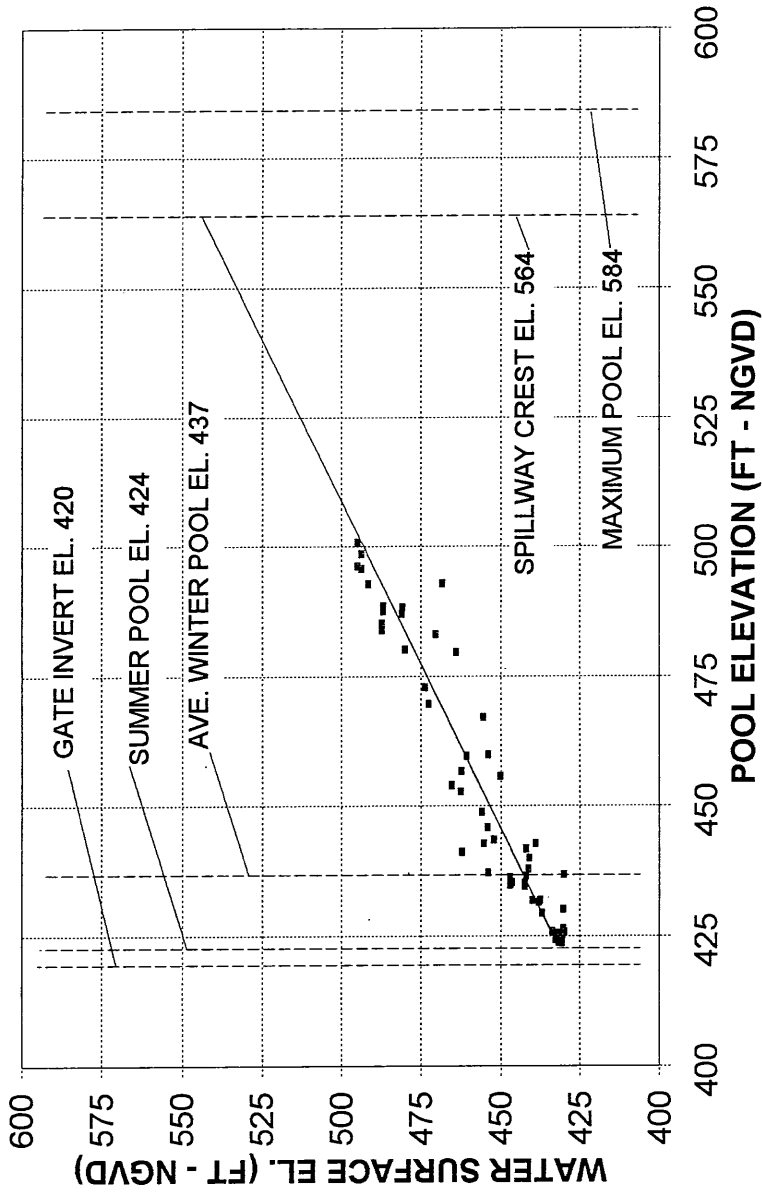
During the winter months, the average water level in PZ-5A is approximately El. 444 for pool levels ranging from El. 435 to 438, as noted in Table II. In summer months the average water level is approximately El. 431 for pool levels ranging from El. 424 to 426. Both the summer and winter piezometer values are higher than the average pool values for their respective season. This may be due to the location of PZ-5A in bedrock where artesian pressures could develop relative to pool level. Based on the available data (October 1, 1992 through October 31, 1994), the piezometer responded to changes in pool elevation as shown in Figures 12. The measured water levels in PZ-5A appear to respond in a linear manner to changes in pool elevation as shown in Figure 21. Based on a linear projection, the water level in the piezometer should rise to El. 544 when the pool reaches the spillway crest, El. 564.

PZ-5A and 5B respond in the similar fashion to fluctuations in pool level. Their piezometric levels vary by no more than 0.1 ft. Similar readings may be attributed to an ineffective seal between the two piezometers. Thus, the piezometers no longer monitor separate zones, instead, they are influenced by the same zone. The lower piezometer, PZ-5A, monitors the piezometric level in the bedrock and the upper piezometer, PZ-5B monitors the piezometric level in the overburden foundation. The rapid response of both piezometers to fluctuation in pool level may be related to the location of PZ-5A in the bedrock and the influence of the steeply sloping rock beneath the east abutment.

During the winter months, the average water level in PZ-5B is approximately El. 444 for pool levels ranging from El. 435 to 438, as noted in Table II. In summer months the average water level is approximately El. 431 for pool levels ranging from El. 424 to 426. Both the summer and winter piezometer values are higher than the average pool values for their respective season. This may be due to the hydraulic connection to PZ-5A in its location in bedrock. Based on the available data (October 1, 1992 through October 31, 1994), the piezometer responded to changes in pool elevation as shown in Figures 13. The measured water levels in PZ-5B appear to respond in a linear manner to changes in pool elevation as

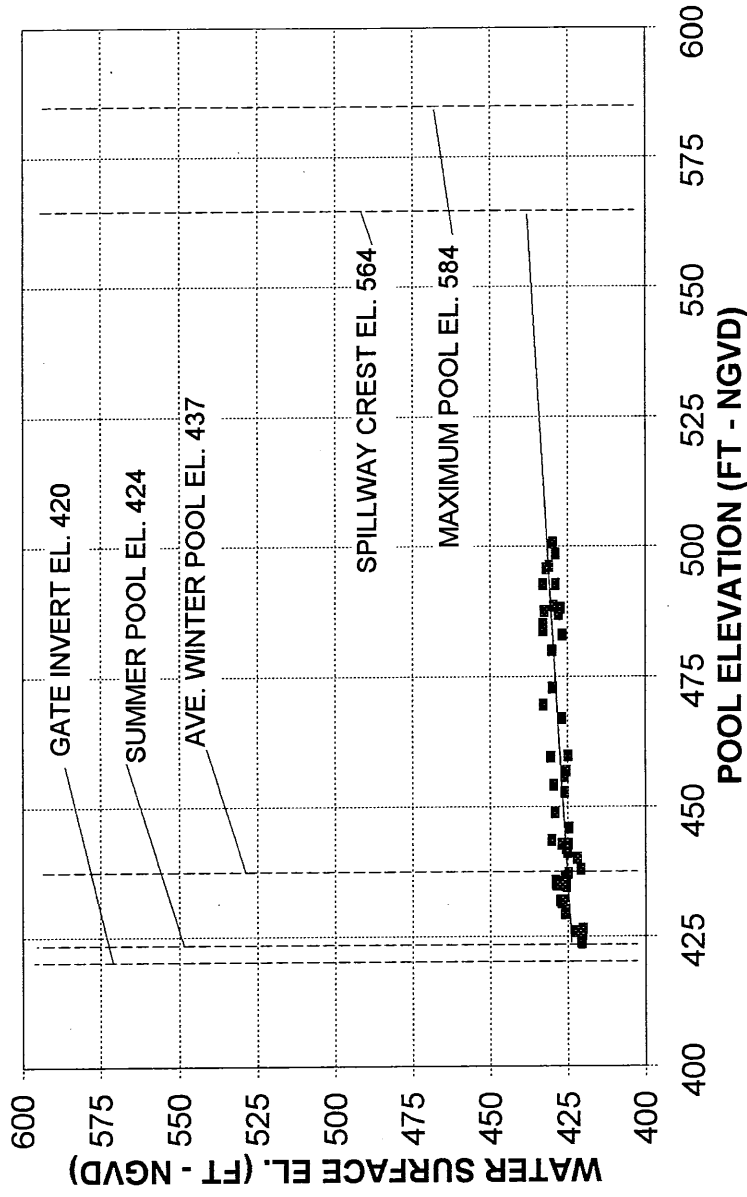
During the winter months, the average water level in PZ-6B is approximately El. 426 for pool levels ranging from El. 435 to 438, as noted in Table II. In summer months the average water level is approximately El. 421 for pool levels ranging from El. 424 to 426. Based on the available data (October 1, 1992 through October 31, 1994), the piezometer responded to changes in pool elevation as shown in Figures 13. The measured water levels in PZ-6B appear to respond somewhat to changes in pool elevation as shown in Figure 24. Based on a linear projection, the water level in the piezometer should rise to El. 438 when the pool reaches the spillway crest, El. 564.

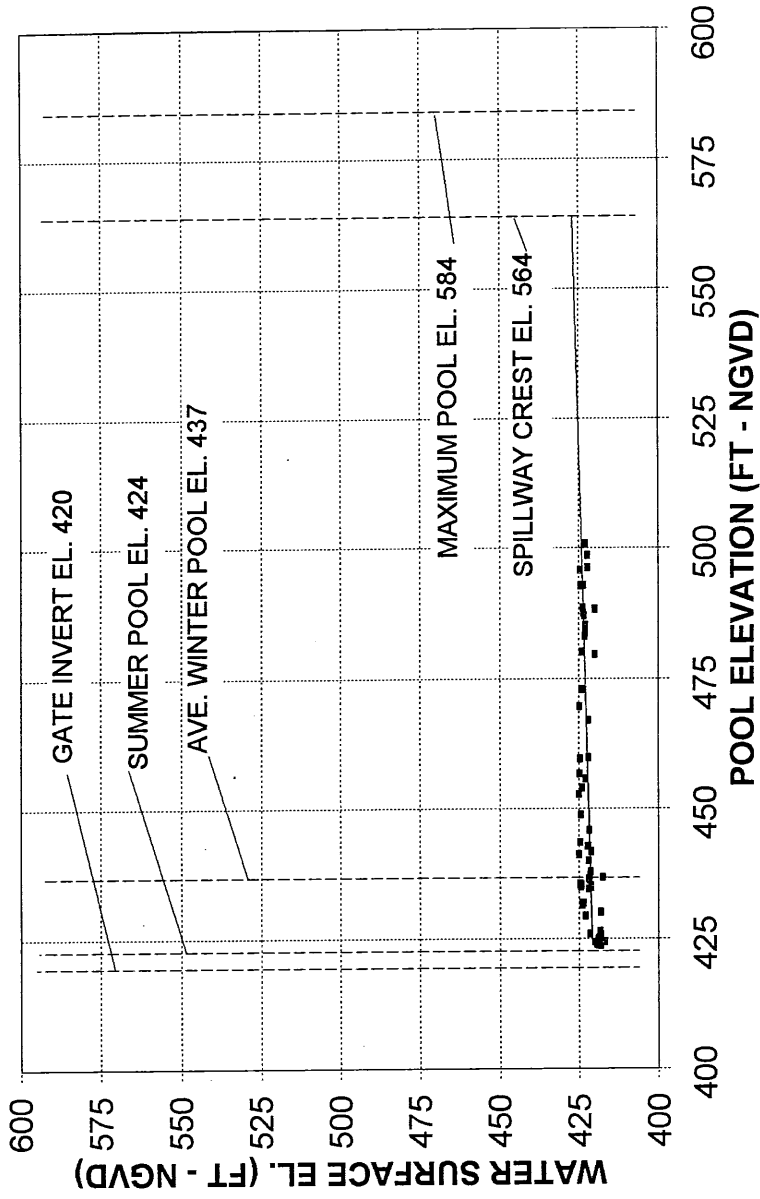
During the winter months, the average water level in PZ-7A is approximately El. 422 for pool levels ranging from El. 435 to 438, as noted in Table II. In summer months the average water level is approximately El. 419 for pool levels ranging from El. 424 to 426. Based on the available data (October 1, 1992 through October 31, 1994), the piezometer responded to changes in pool elevation as shown in Figures 12. The measured water levels in PZ-7A appear to respond somewhat to changes in pool elevation as shown in Figure 25. The small range of piezometric levels for PZ-7A is to be expected due to its location beneath the downstream slope with resulting connection through jointed bedrock or fill/rock interface to tailwater outlet. Based on a linear projection, the water level in the piezometer should rise to El. 427 when the pool reaches the spillway crest, El. 564.

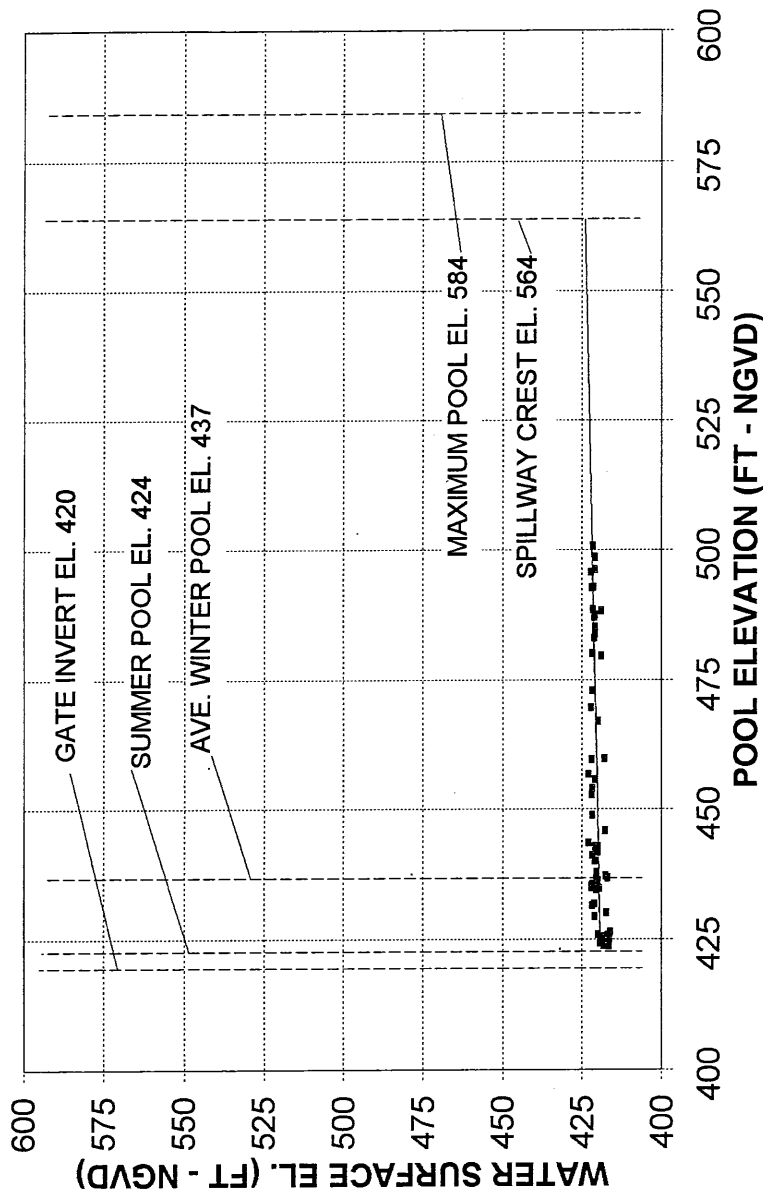
During the winter months, the average water level in PZ-8 is approximately El. 421 for pool levels ranging from El. 435 to 438, as noted in Table II. In summer months the average water level is approximately El. 418 for pool levels ranging from El. 424 to 426. Based on the available data (October 1, 1992 through October 31, 1994), the piezometer responded to changes in pool elevation as shown in Figures 14. The small response range of PZ-8 is representative of its location beneath the downstream slope of the embankment and the toe drain that outlets to tail water. The measured water levels in PZ-8 appear to respond somewhat to changes in pool elevation as shown in Figure 26. Based on a linear projection, the water level in the piezometer should rise to El. 424 when the pool reaches the spillway crest, El. 564.
